REPORT OF APOLLO 204 REVIEW BOARD

**APPENDIX D
PANEL 18**

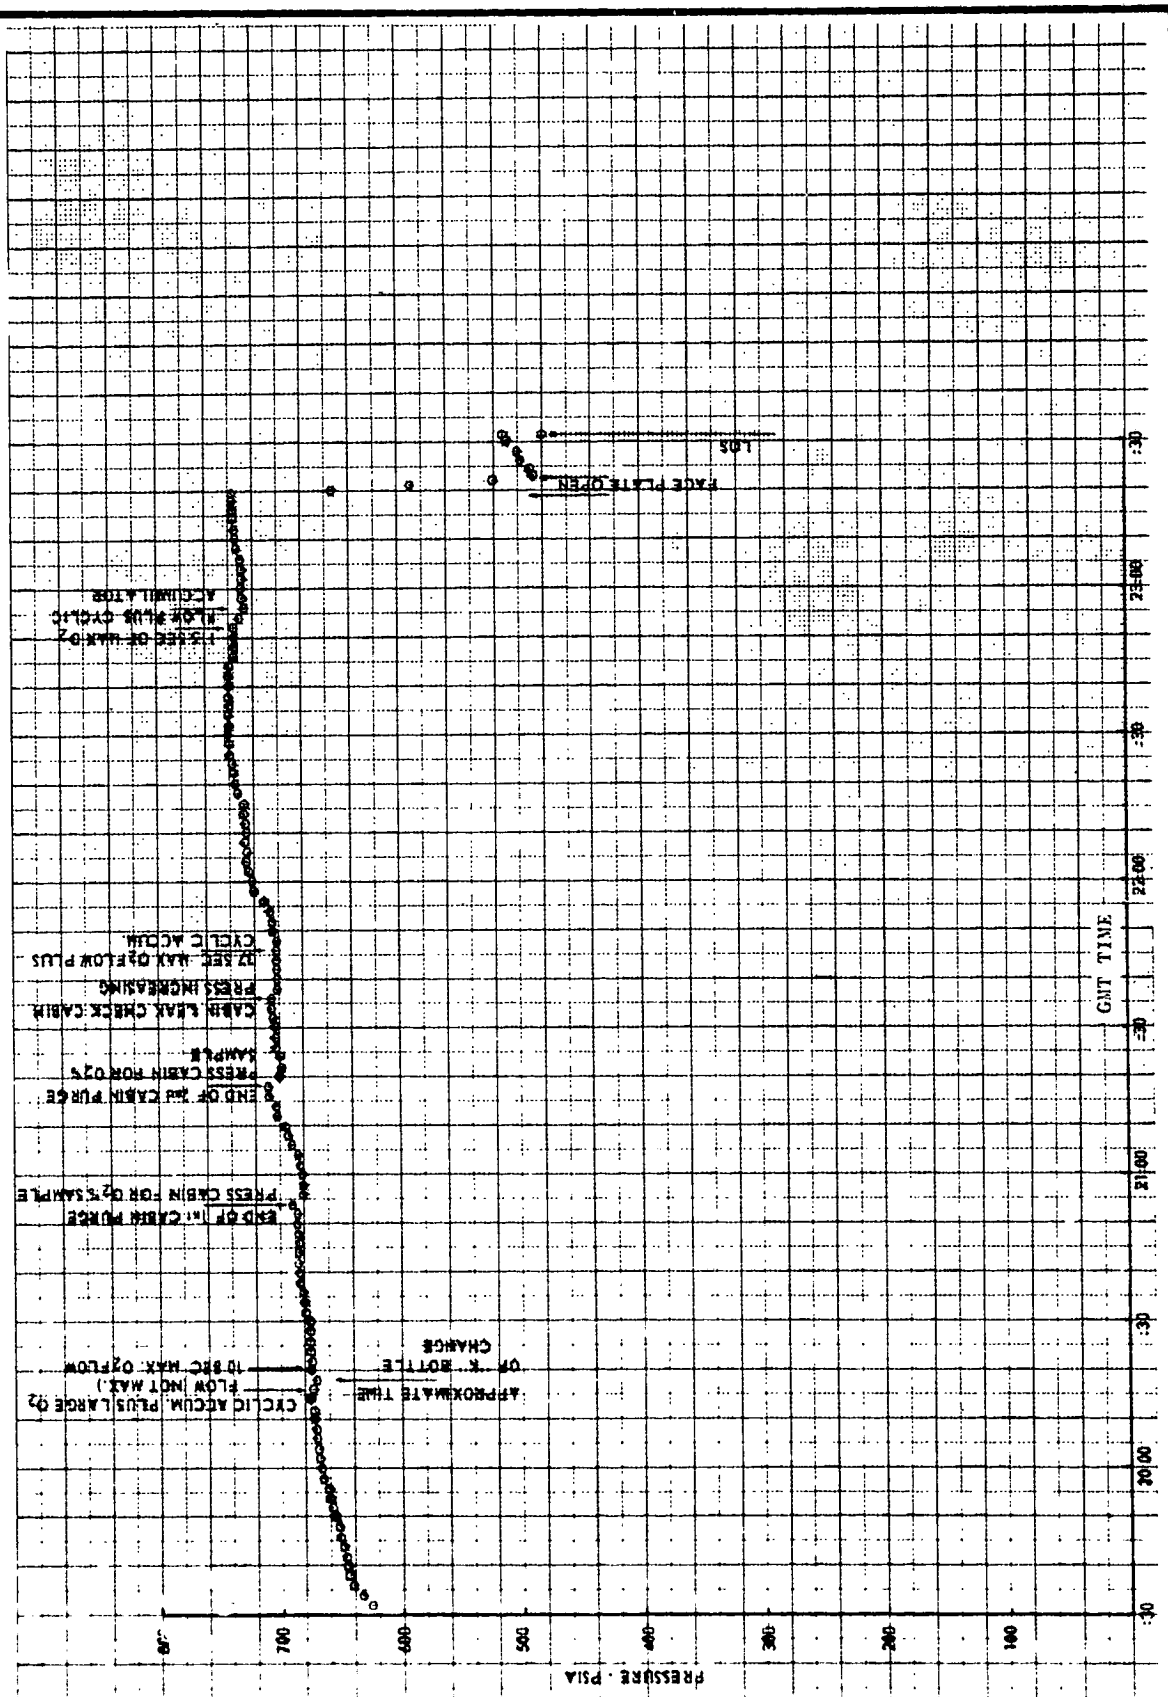
ENCLOSURE 18-13

SURGE TANK PRESSURE PROFILE

| ITEM NO. | ITEM | STATUS | | ANALYSIS | |
|---|---|--|---|---|---|
| | | It is concluded that the oxygen surge tank pressure decay was the result of high O ₂ flows into the suit loop. | | | |

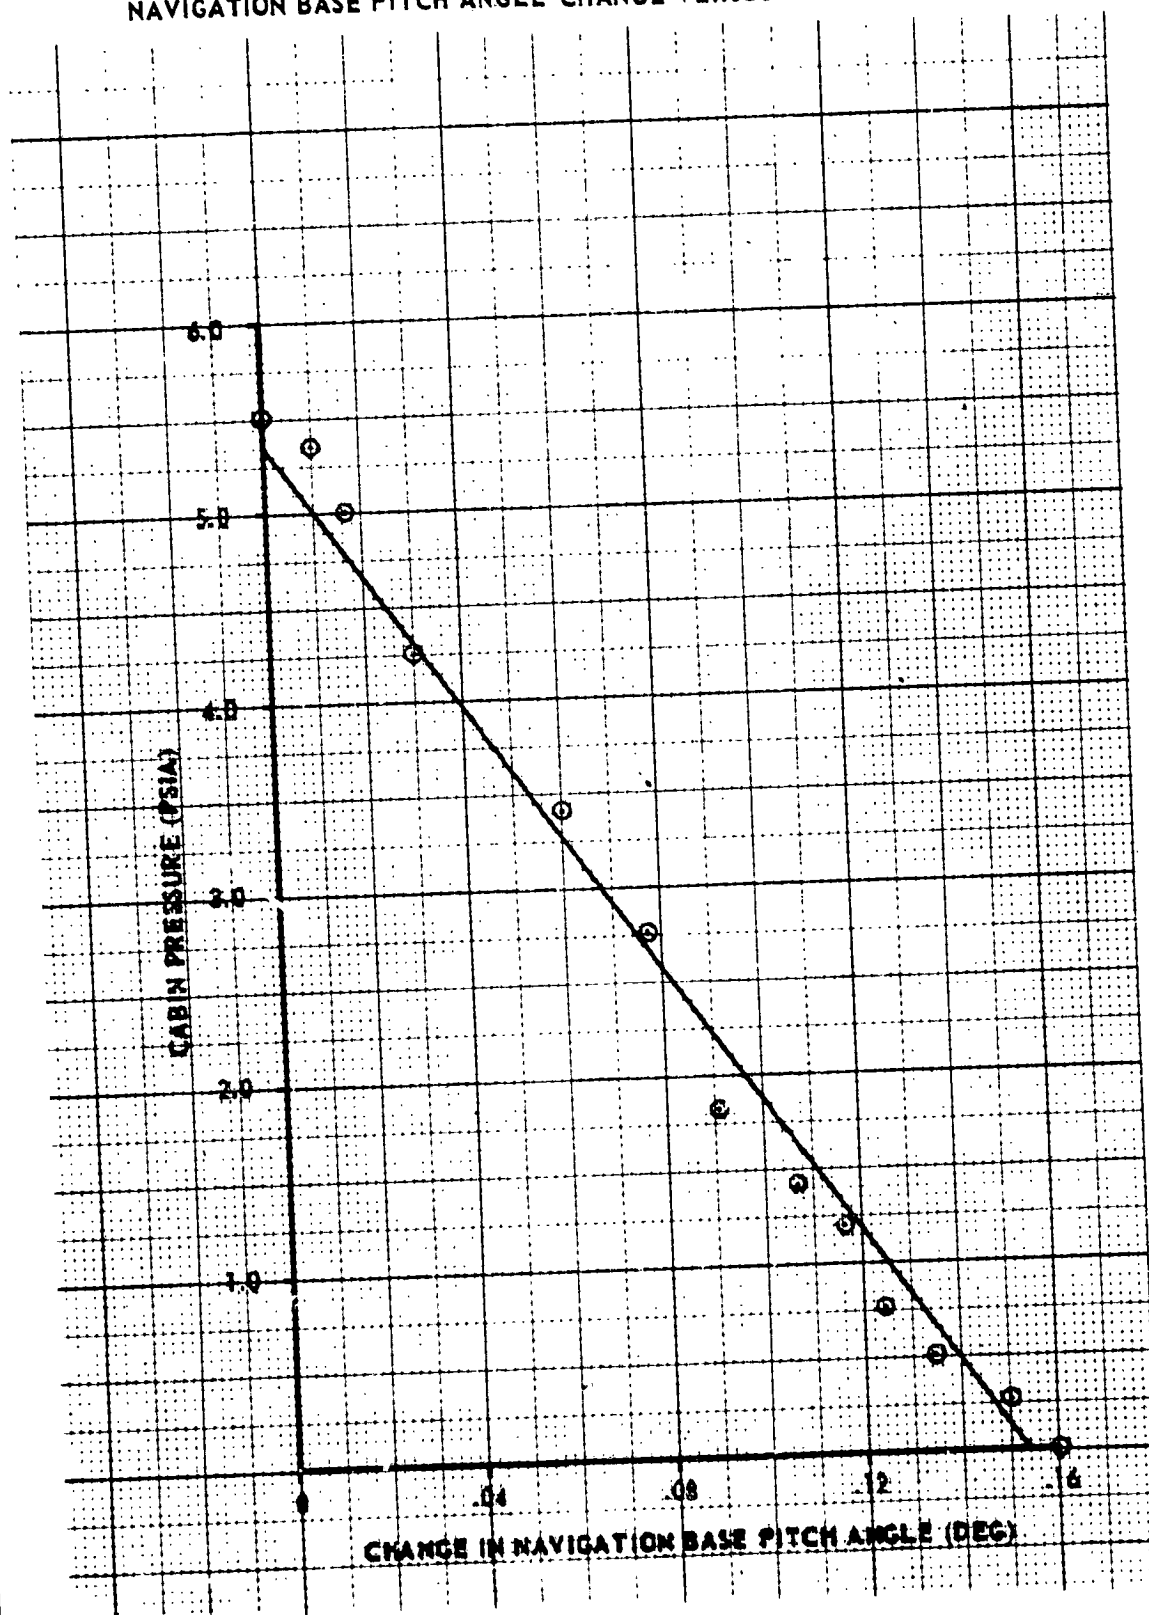
ENCLOSURE 18-18

NAVIGATION BASE PITCH ANGLE CHANGE VERSUS CABIN PRESSURE

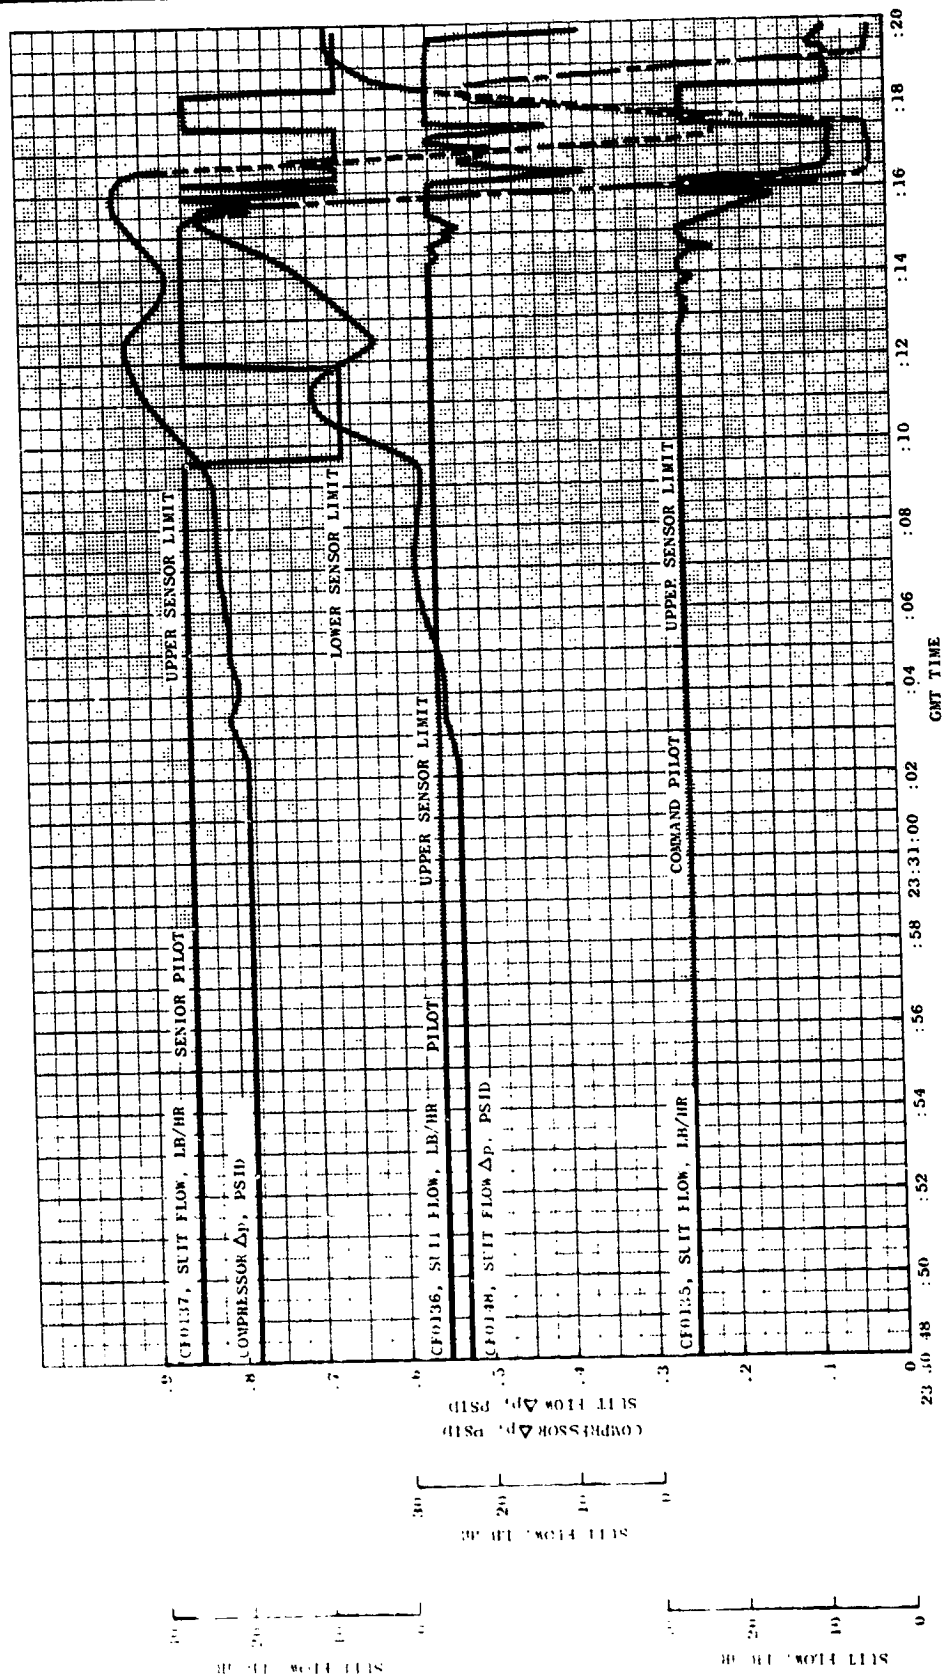
ENCLOSURE 18-20

SUIT O₂ FLOW RATES

| ITEM NO. | ITEM | STATUS | | ANALYSIS | |
|---|---|--|---|---|---|
| | | Characteristic of suit flow indications with restricting caused by Command Pilot movements or physical activity. The time period for fluctuations in the Senior Pilot suit flow coincides with increase muscular activity indicated by physiological data. | | | |

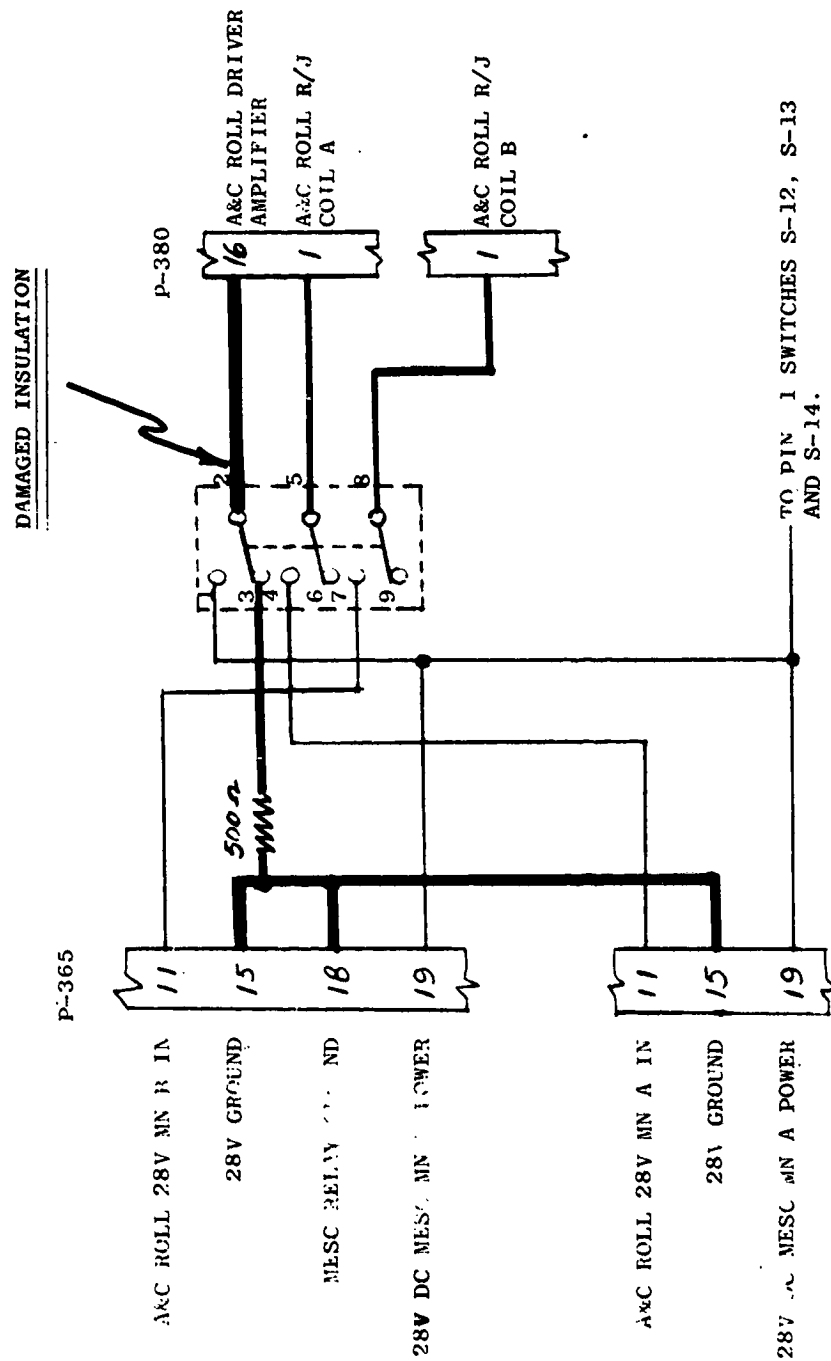
ENCLOSURE 18-41

Enclosure 18-41: Main Display Console Panel Number 6 Switch S-11 Wiring
